# VEHICLE INSPECTION REPORT

**BN21AOW**

## Iveco Daily 35-120

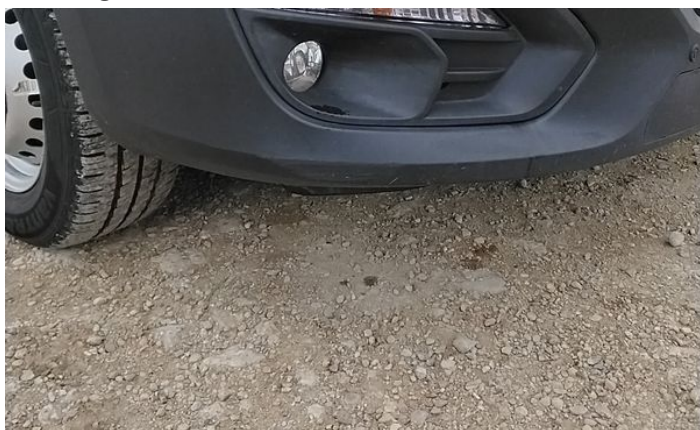
1: Bumper Front Moulding  
Scuffed (Unpainted)  
UpTo 100mm

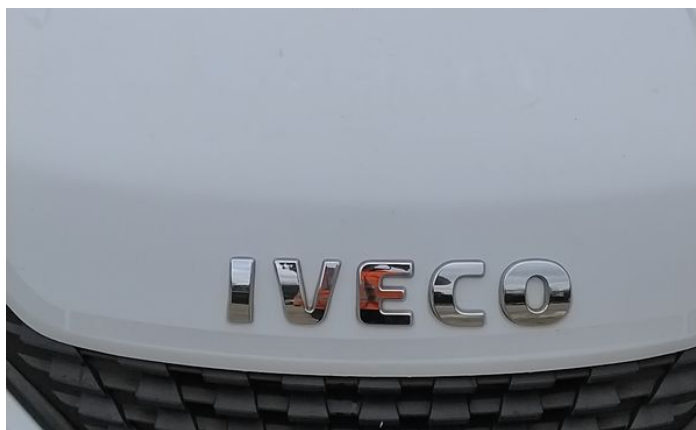
2: Bonnet  
Chipped  
Multiple Chips

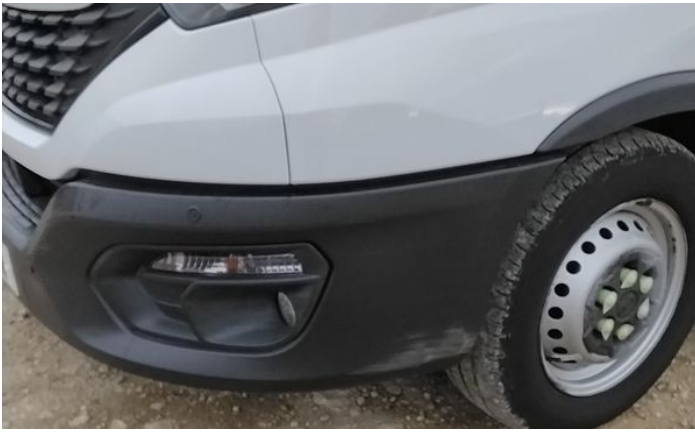
3: Bumper Front Moulding  
Scuffed (Unpainted)  
Over 100mm

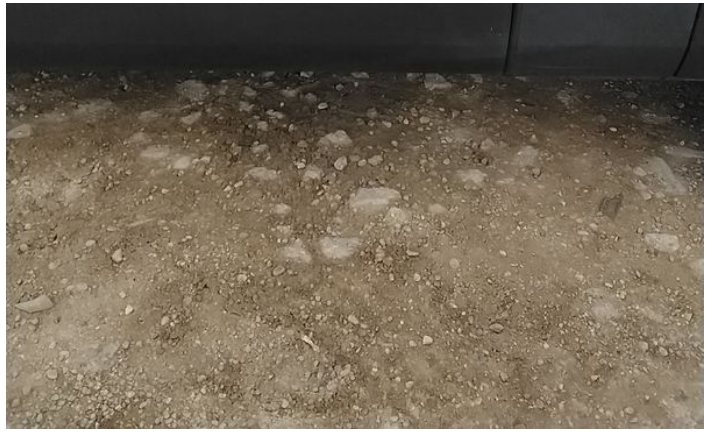
4: Door Moulding nsr  
Scuffed (Unpainted)  
UpTo 100mm

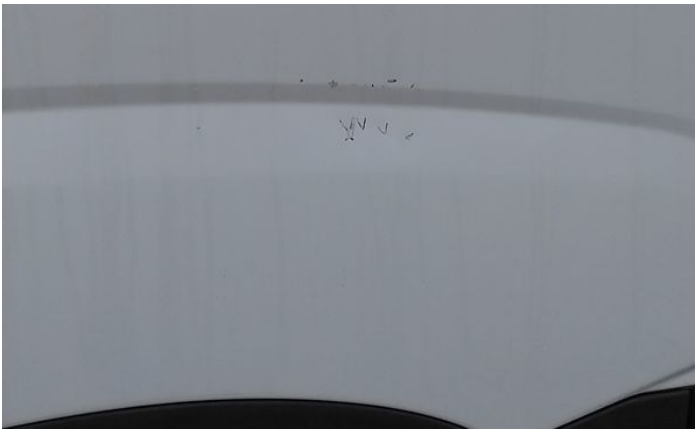
5: Qtr Panel osr  
Scratched  
UpTo 25mm Thru Paint

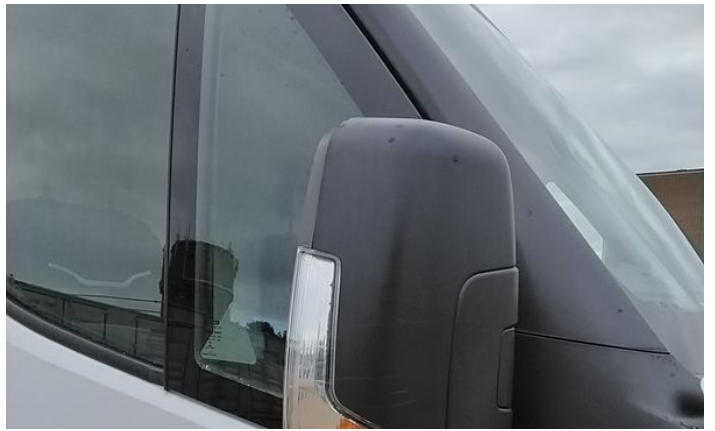
6: Door Mirror Assy osf  
Scuffed (Unpainted)  
UpTo 100mm

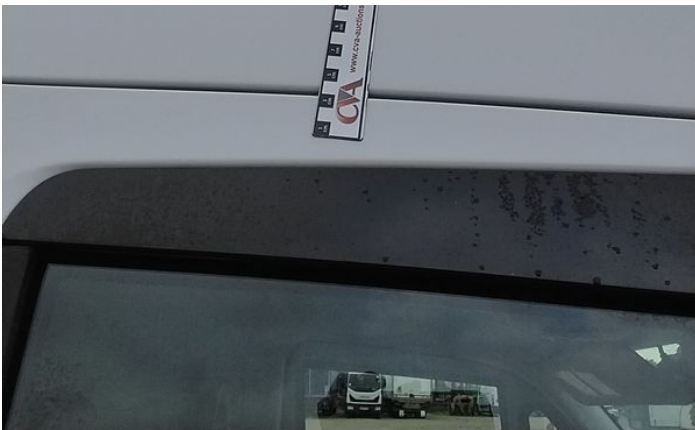
7: Qtr Panel osr  
Dented  
With Paint Damage

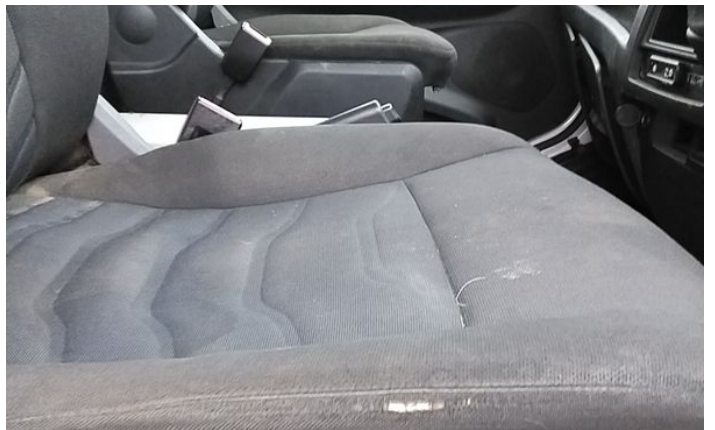
8: Seat Base Cover osf  
Holed  
Over 3mm
